NATIONAL PHOTOGRAPHIC INTERPRETATION CENTER

CLOSED ENEMY ROADS

LAOS PANHANDLE

Attachment to N 1784
22 September 1969
Page 1 of 4

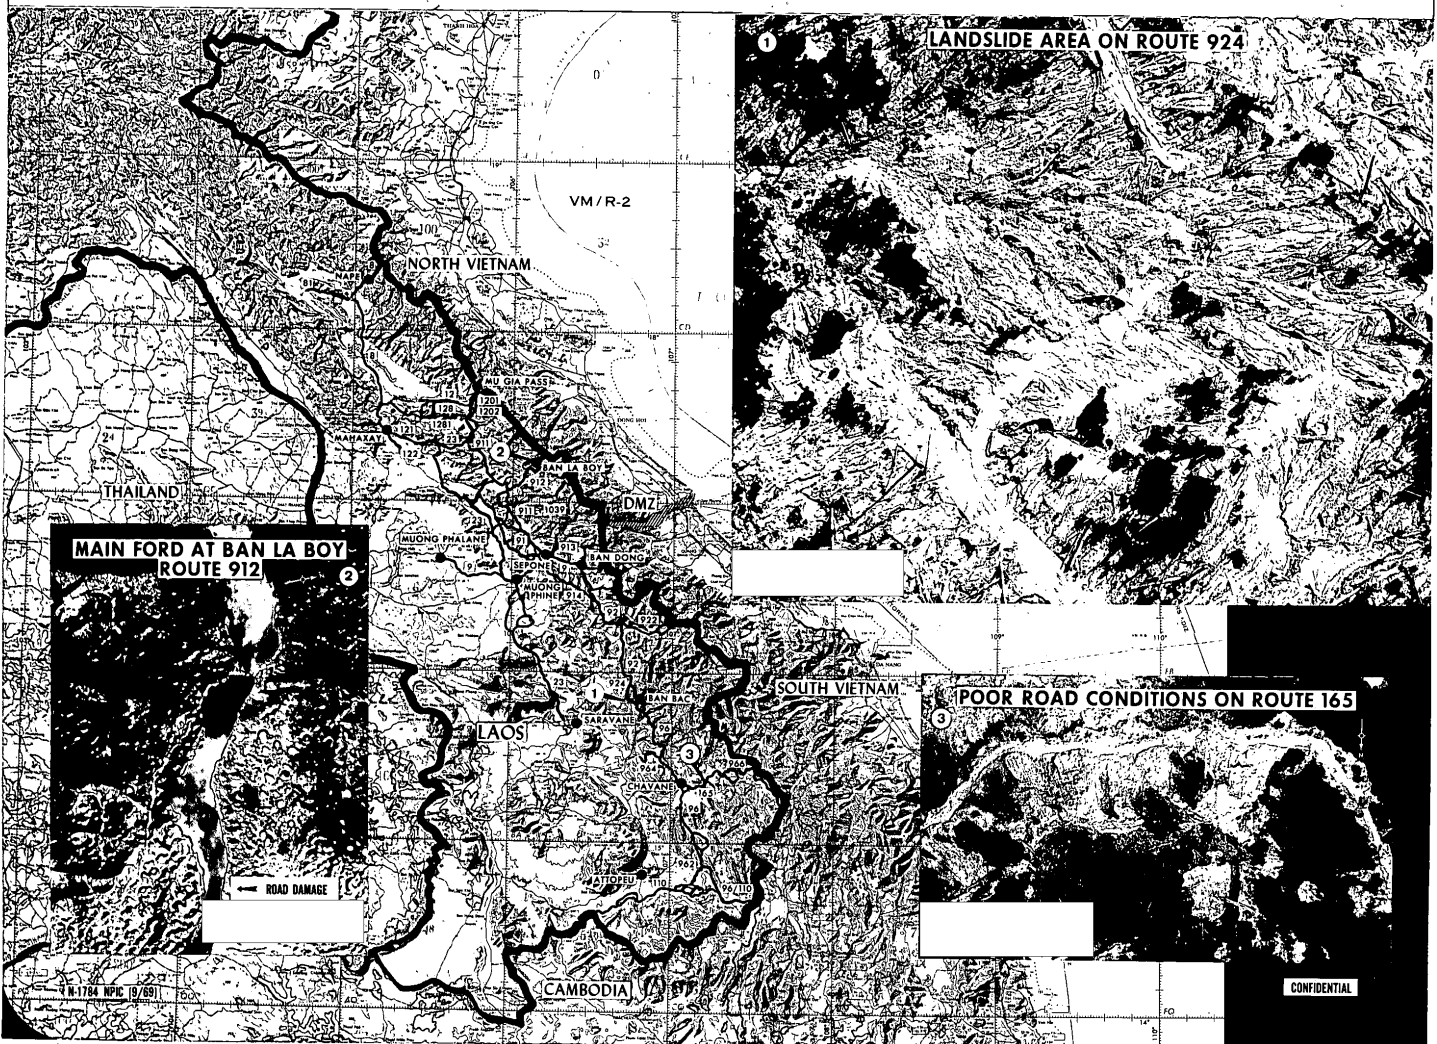
INSET ONE - THIS TYPICAL LANDSLIDE AREA IS
LOCATED ON ROUTE 924 NEAR BAN BAC. [REDACTED]

INSET TWO - THE MAIN FORD AT BAN LA BOY IS
WHERE ROUTE 912 CROSSES THE NAM TA LE (RIVER).
SEVERAL POINTS ON THIS SEGMENT NEED REPAIR.
BYPASSES AROUND THIS FORD ARE ALSO UNSERVICEABLE.

INSET THREE - THE CONDITION OF ROUTE 165 AND 966
BECOMES PROGRESSIVELY WORSE FROM WEST TO EAST.
THE EXAMPLE, ROUTE 165 EAST OF CHAVANE, IS TYPICAL
OF MANY PLACES ALONG THE ROAD WHICH WILL NEED
REPAIR TO BECOME SERVICEABLE. [REDACTED]

THE MAP DEPICTS THE MAJOR COMMUNIST ROAD NET IN
THE LAOS PANHANDLE. SCALE IS 1:1,000,000.
